Our Reference: 24160.92351
Your Reference: Legacy Way Ground Water Levels - July 2017

03 August 2017

Re: Legacy Way Groundwater Levels July 2017

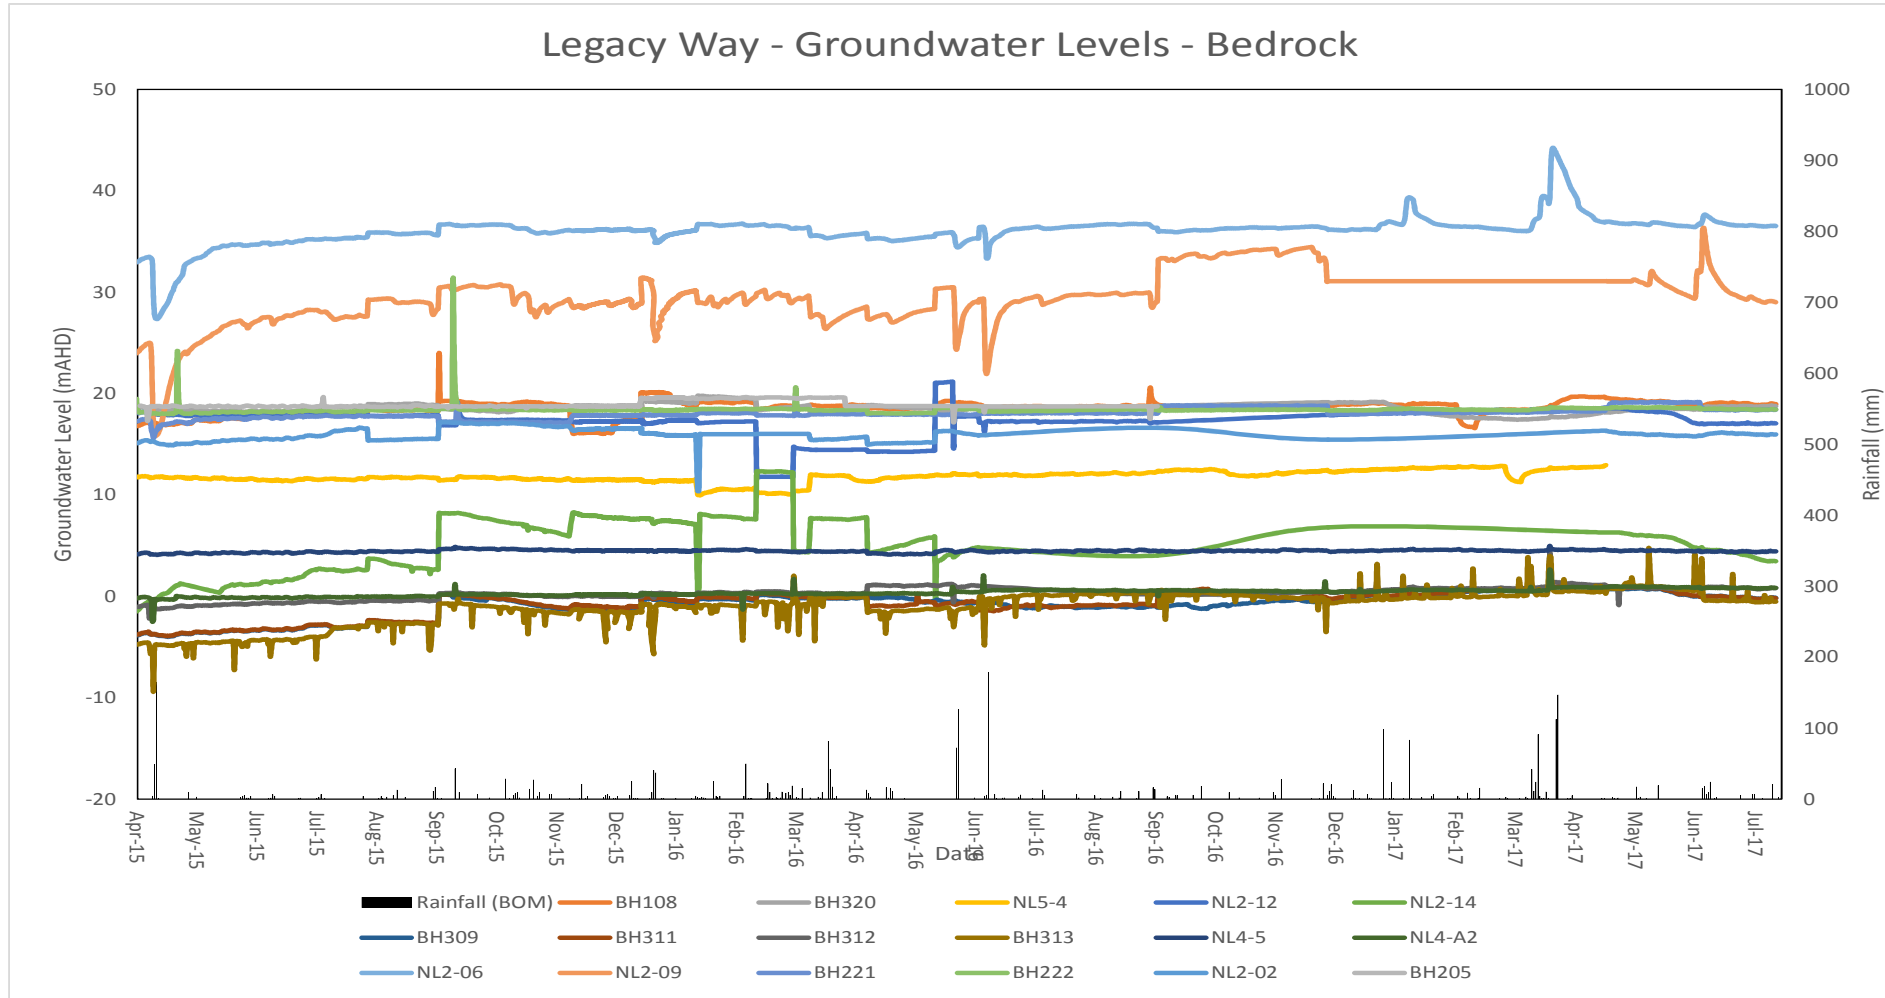
Figure 1 - Groundwater levels – bedrock

Groundwater in the Toowong Cemetery and surrounds, the groundwater level in boreholes BH108, BH320, NL2-14 had historically been reported as exceeding the 200% of the natural variation and was associated with the tunnelling activities in close proximity to the boreholes. BH108 showed slight increases in groundwater levels corresponding with the moderate rainfall events of 15th-18th June and 16th July, and a gradual decrease in groundwater levels over the rest of the month. BH320 showed a gradual increase in water levels until the end of June, after which groundwater levels were stable. Groundwater levels in NL 2-14 showed a steady decrease in groundwater level since the last monitoring round on 13th June, corresponding with the drier winter climate. NL 2-14 has historically displayed a high variation of up to 3.5m since the March 2016 monitoring period. It is expected that this location will continue to fluctuate based on seasonal trends.

Along the tunnel alignment in Rosalie and surrounding areas, the groundwater level in boreholes BH309, BH311, BH312, BH313 had previously been reported as historically exceeding the 200% of the natural variation and was associated with tunnelling activities in close proximity to the boreholes. These boreholes are assessing water levels in the bedrock, and drawdown from tunnelling operations was predicted in this area. BH313 continued to show sudden increases in groundwater levels corresponding to rainfall events confirming observations from the previous monitoring round that the well has been compromised due to roadway water ingress. BH309 and BH311 have decreased slightly since the June 2017 monitoring event, corresponding with decreased rainfall.

Groundwater monitoring of the Eastern Portal area continued, with slow recovery noted in the bores. BH221 and BH222 remained static since the June 2017 monitoring period with no fluctuation noted due to rainfall events. NL2-06, and NL2-09 in upper Clifton Terrace and lower Clifton Terrace, respectively, both showed significant groundwater elevation increases correlating with the rainfall events of 11th – 18th June. Groundwater levels in both wells then decreased over the remainder of the monitoring period, and by 21st July were consistent with levels recorded in the week 4th – 10th June.

At the Western portal, groundwater levels in NL2-02 were consistent with the June monitoring round. It has been previously noted that levels at this site may be impacted by localised rainfall events and potentially influenced from external activities (i.e. Mt Coot-Tha Quarry and the botanic garden ponds). The monitoring well showed groundwater levels increased slightly in June and were stable in July.

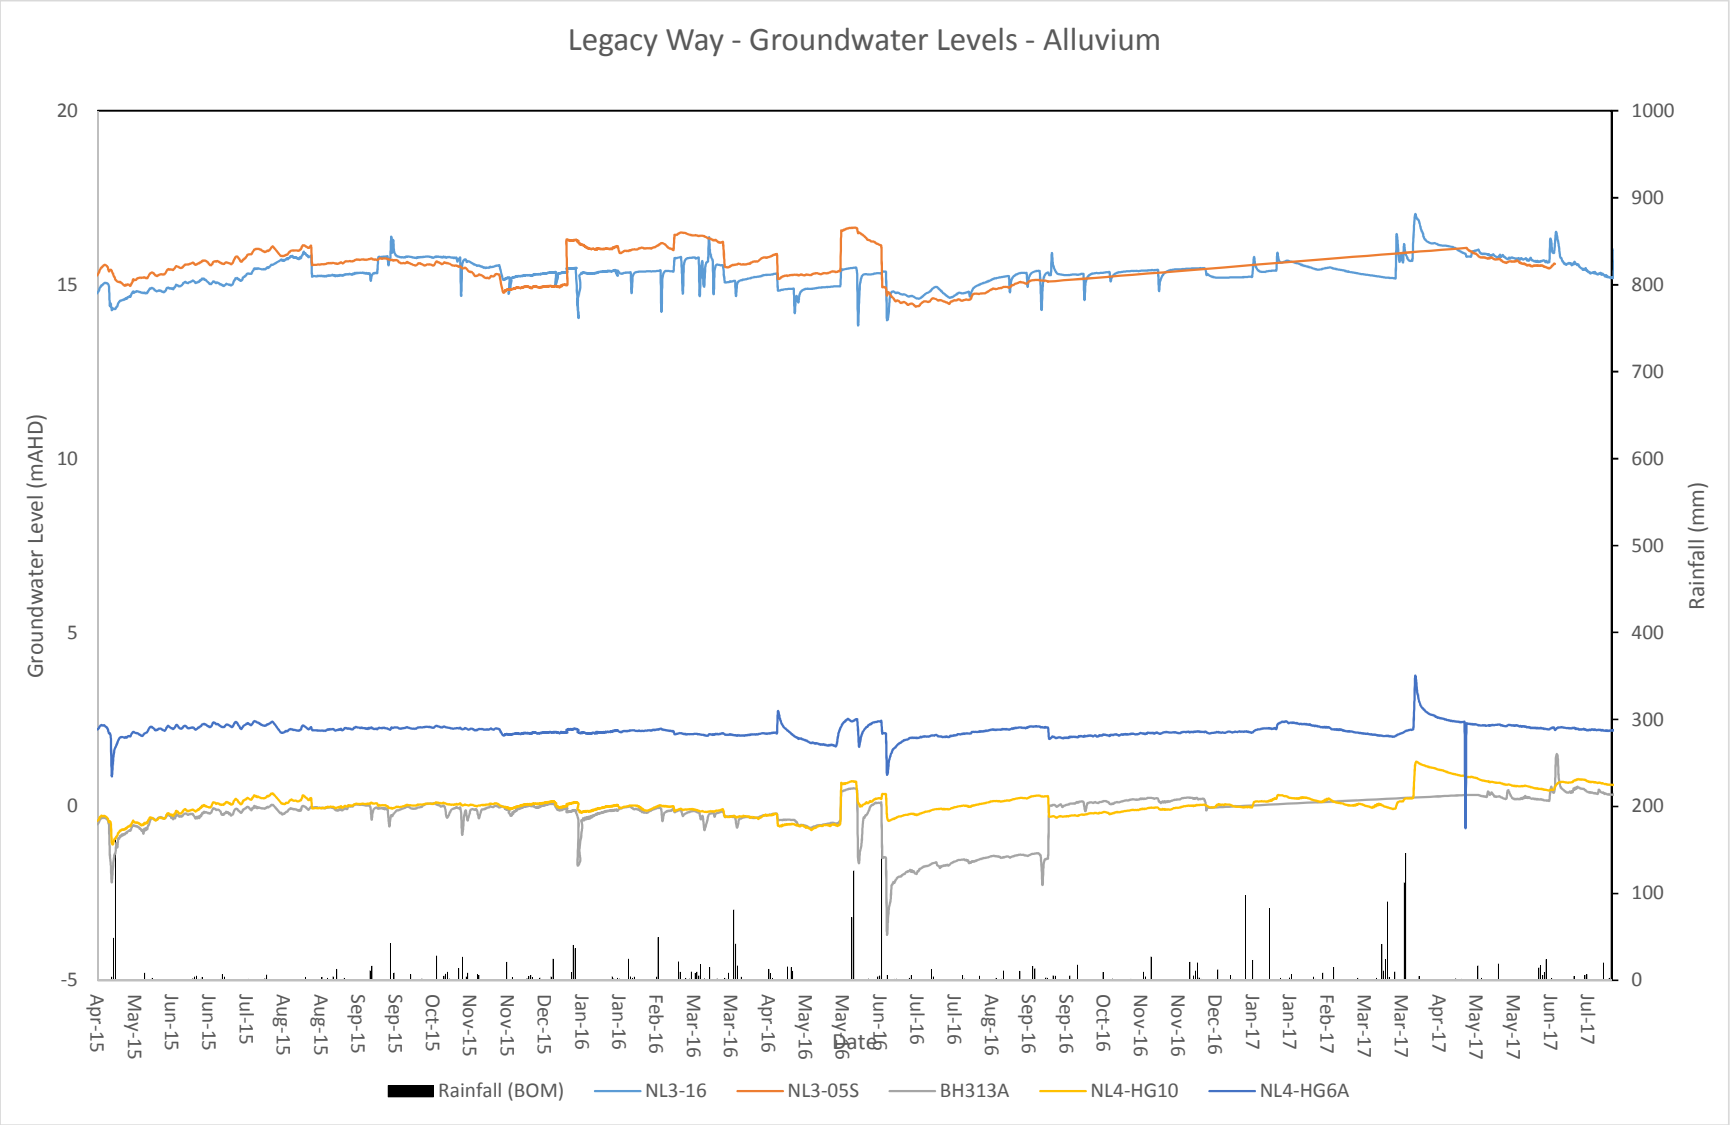
Figure 2 - Groundwater levels – alluvium

Of the alignment borehole locations monitoring the alluvium adjacent to the tunnel alignment, water levels in well NL4-HG6A have been stable since the June monitoring round, and NL4-HG10 showed a slight increase in water levels through June, and a gradual decrease in levels during July. Wells NL3-16 and BH313A showed an overall decrease in water levels in the June – July monitoring period, but both wells showed spikes in elevation corresponding to the rainfall events of 11th – 18th June and 16th July.
