# Corrective and Preventative Action Report

CPAR # 000116

27/02/2017

The Western Ventilation Stack Outlet, as described in the Legacy Way Environmental Authority ERA51- EPPR02587314.

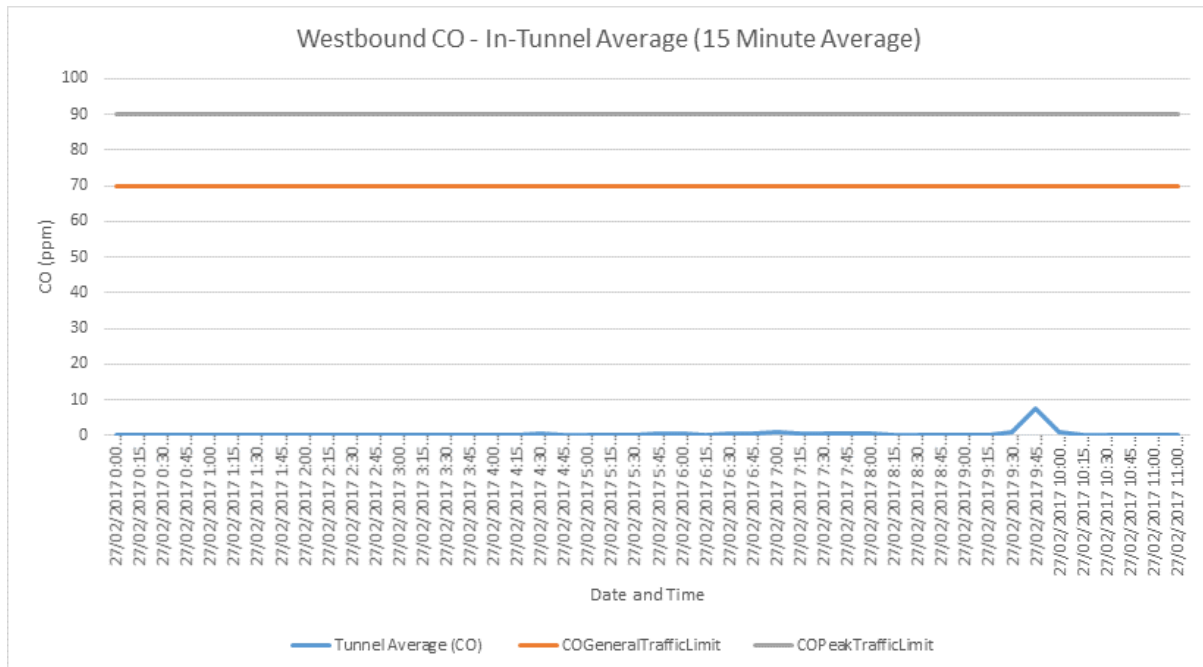
Please note that In-tunnel air quality did not exceed the 15 minute average criteria for any parameter. There was a spike in visibility, however, this remained under the specified criteria level.

Figure 1 - Westbound In Tunnel CO (15 Minute)

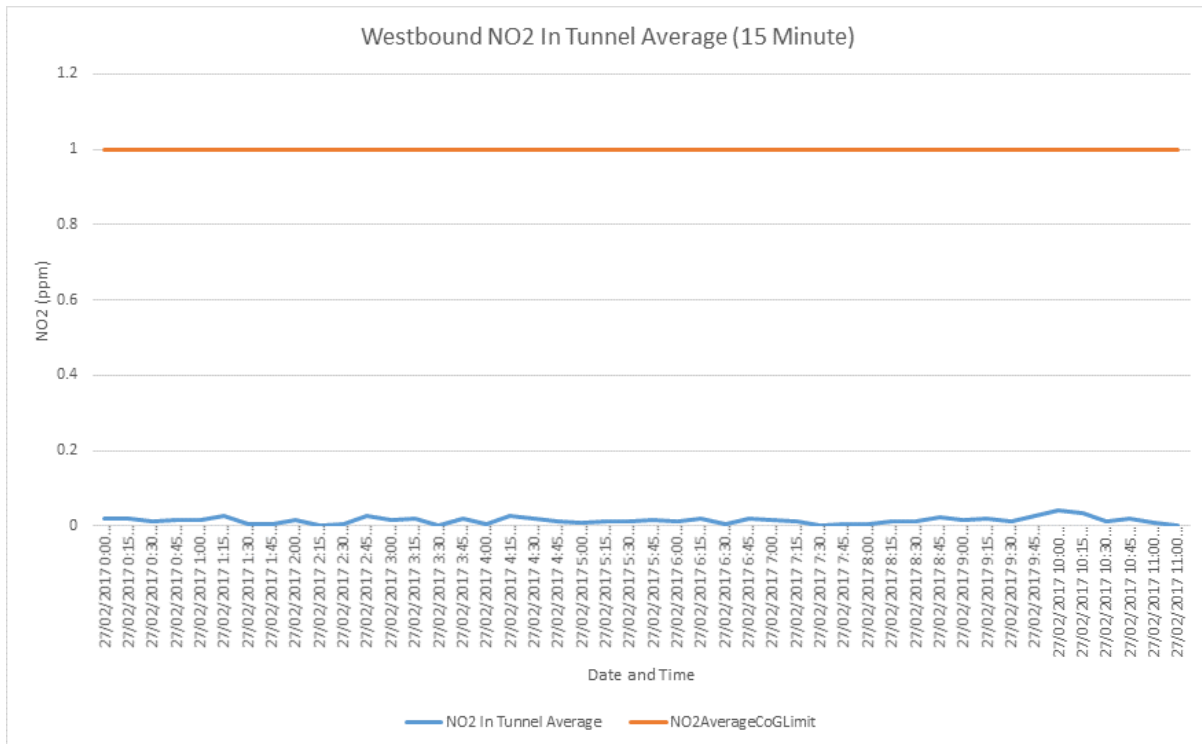
Figure 2 - Westbound In Tunnel NO2 (15 Minute)

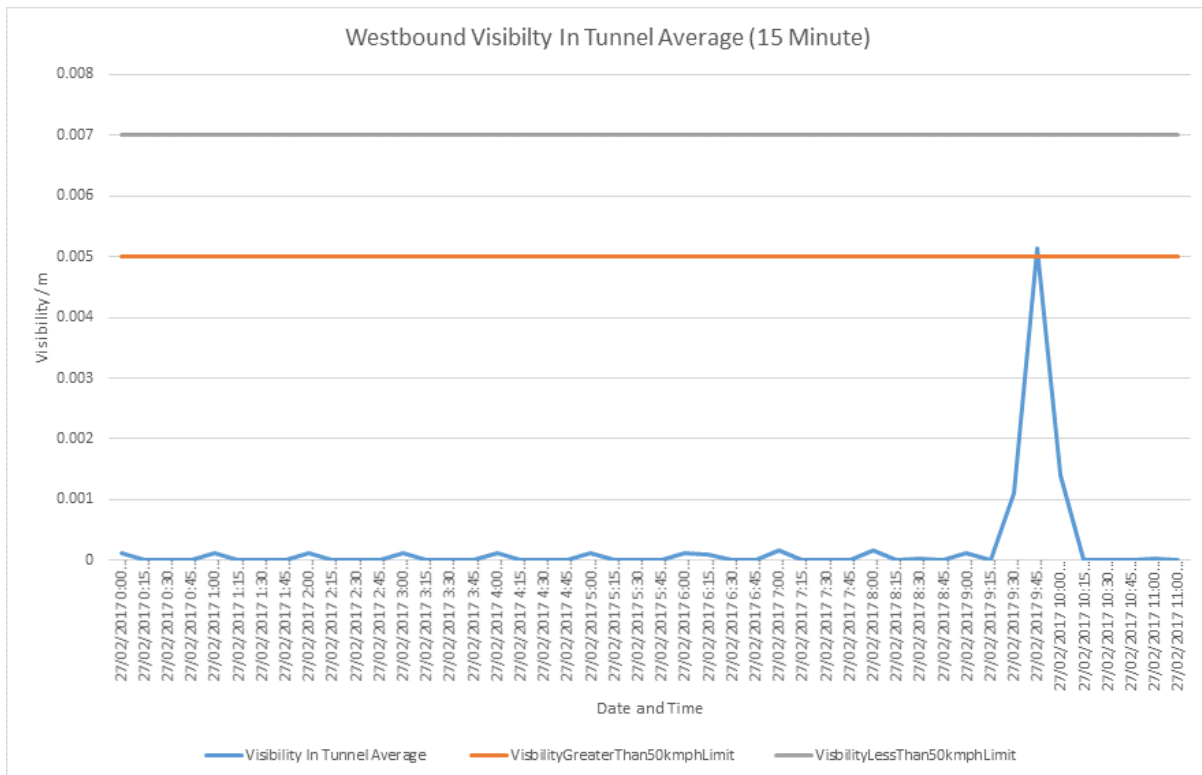
Figure 3 - Westbound In Tunnel Visibility (15 Minute)

The above visibility / m of 0.00514 is not an exceedance because the traffic speeds were below 50km/hr, which means that the limit for measuring an exceedance is 0.007 / m (per the Environmental Authority).

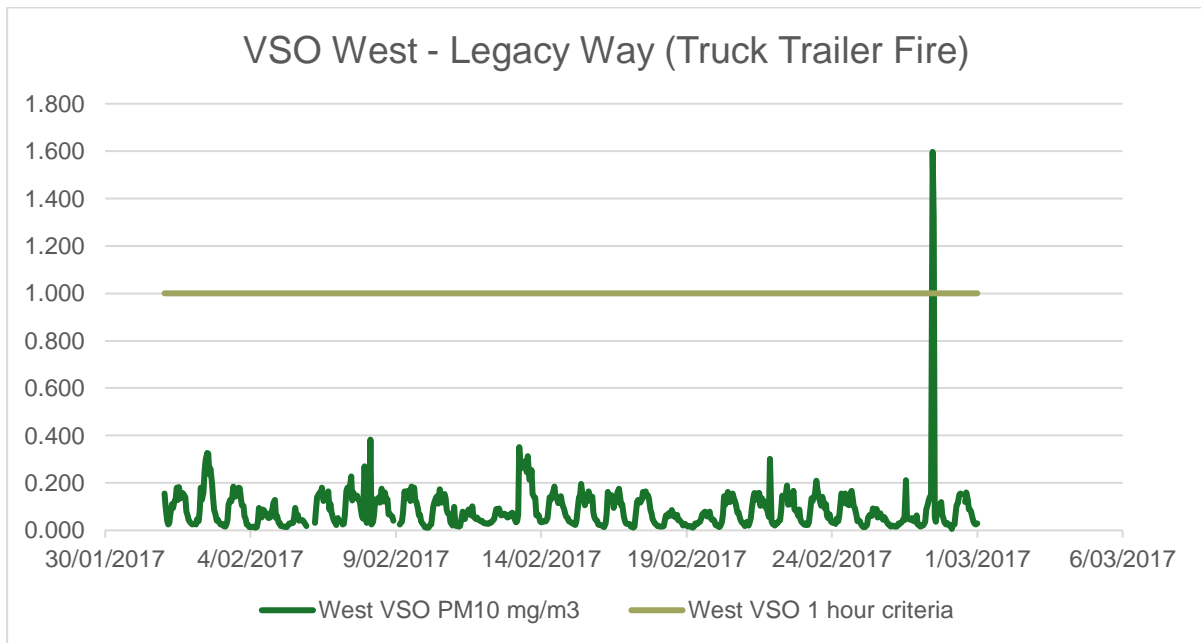
Figure 5 - VSO West Exceedance due to Truck Trailer Fire 27/2/2017

The above spike in the graph illustrates exceeding the PM10 1 hour criteria in the west ventilation stack outlet during the truck trailer fire incident. It is important to note that there was no exceedance of in-tunnel air quality, nor at the ambient air quality stations at the ends of the tunnel.

West VSO PM<sub>10</sub> – 1 hour – 1.597 mg/m<sup>3</sup> on 27/02/17 11:00am

West VSO PM<sub>10</sub> – 1 hour – 1.312 mg/m<sup>3</sup> on 27/02/17 12:00pm

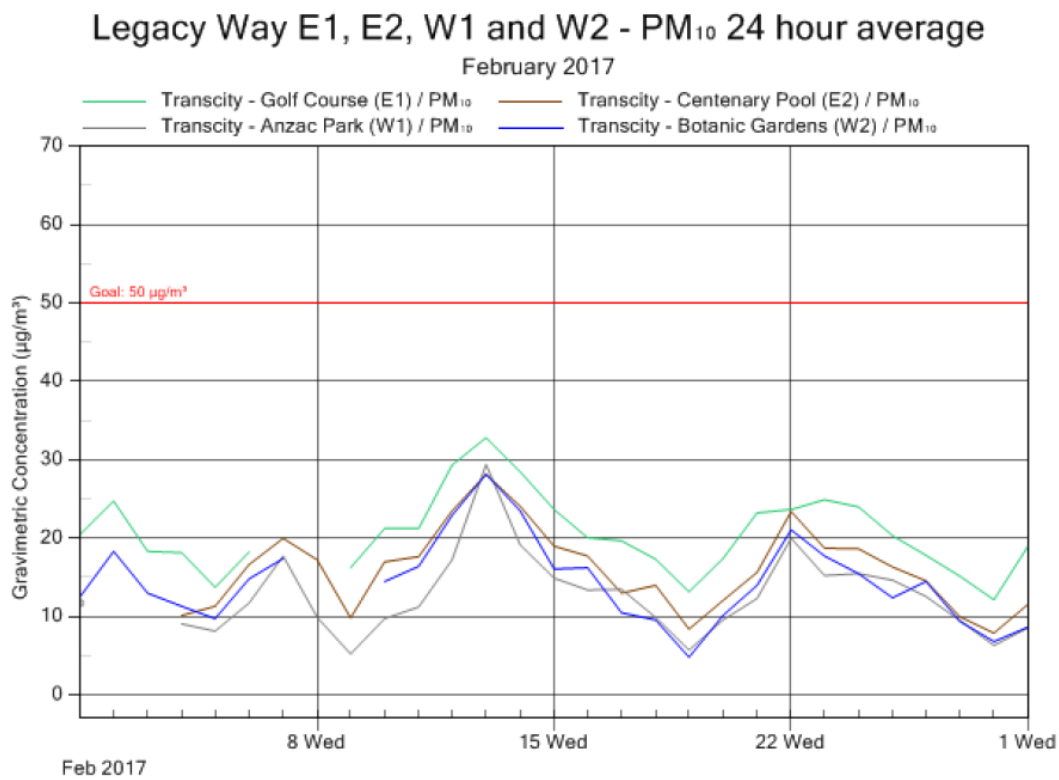
Please note that the ambient PM10 and PM2.5 air quality all remained within the 24 hour criteria as per the Environmental Authority (no exceedance of ambient air quality).

Figure 6 - Legacy Way (E1, E2, W1 and W2) PM10 graph for Feb 2017

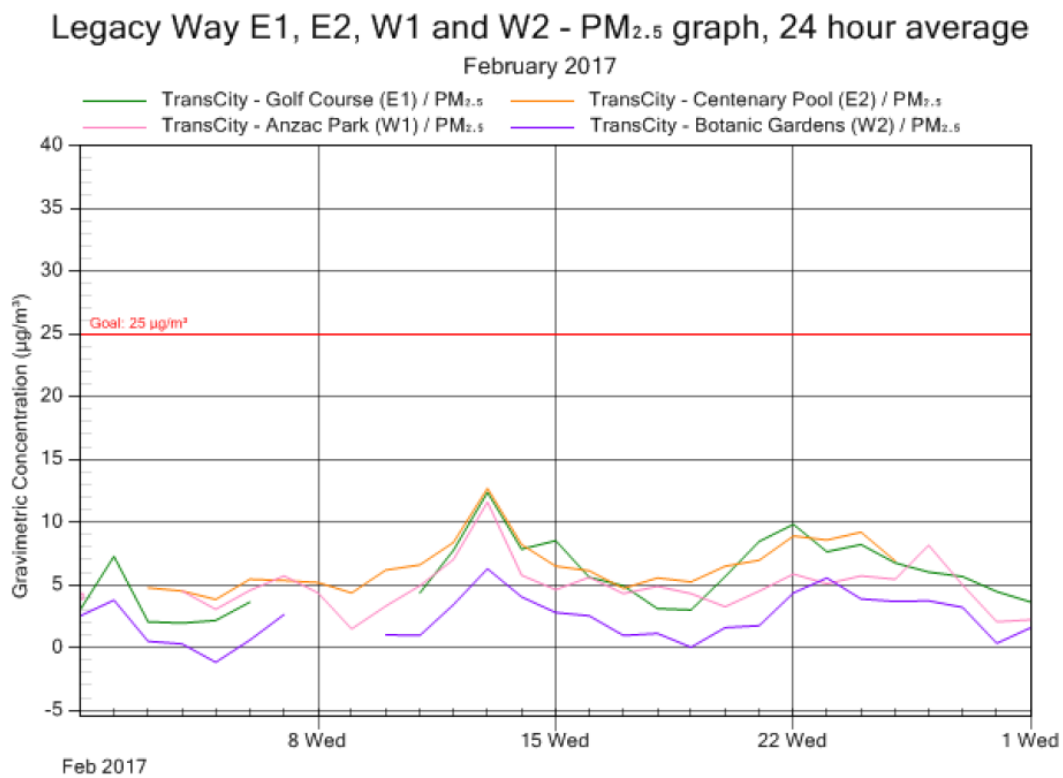
Figure 7 - Legacy Way (E1, E2, W1 and W2) PM2.5 graph for Feb 2017
