CLEM7 in-tunnel air quality

Monthly trend report – May 2018

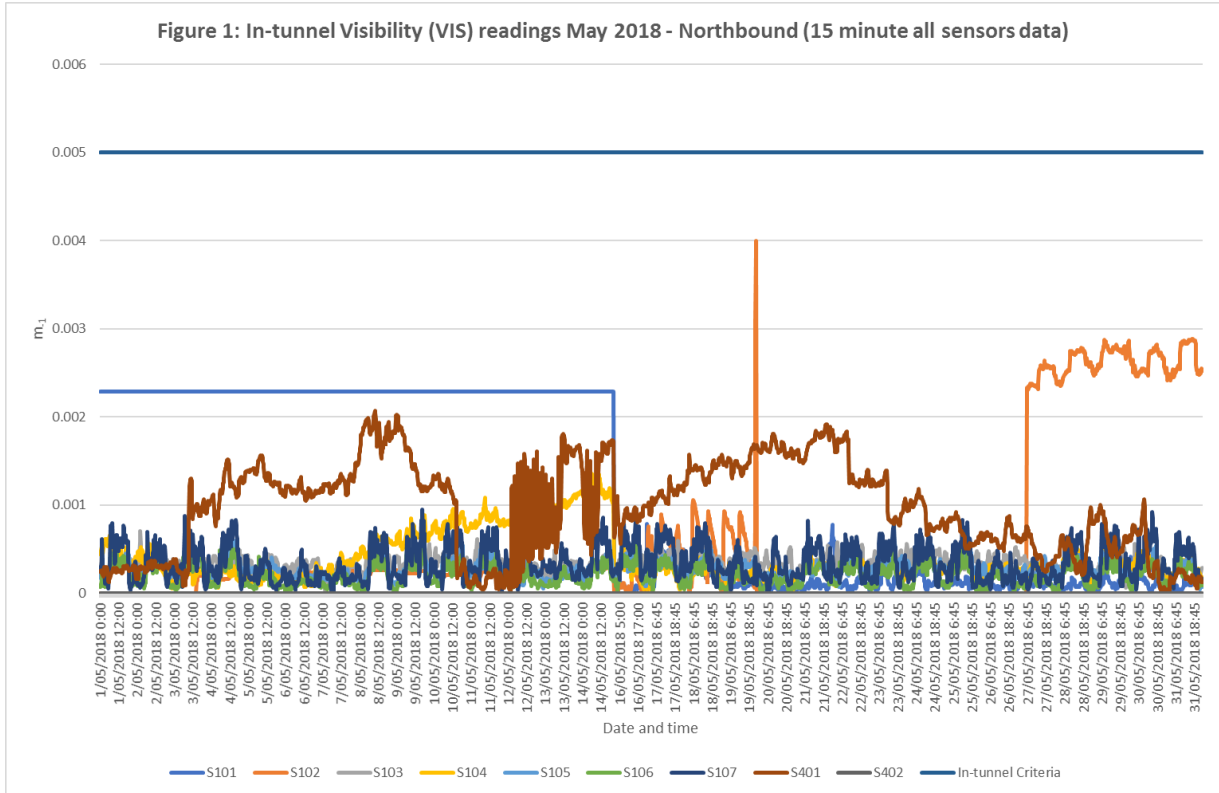
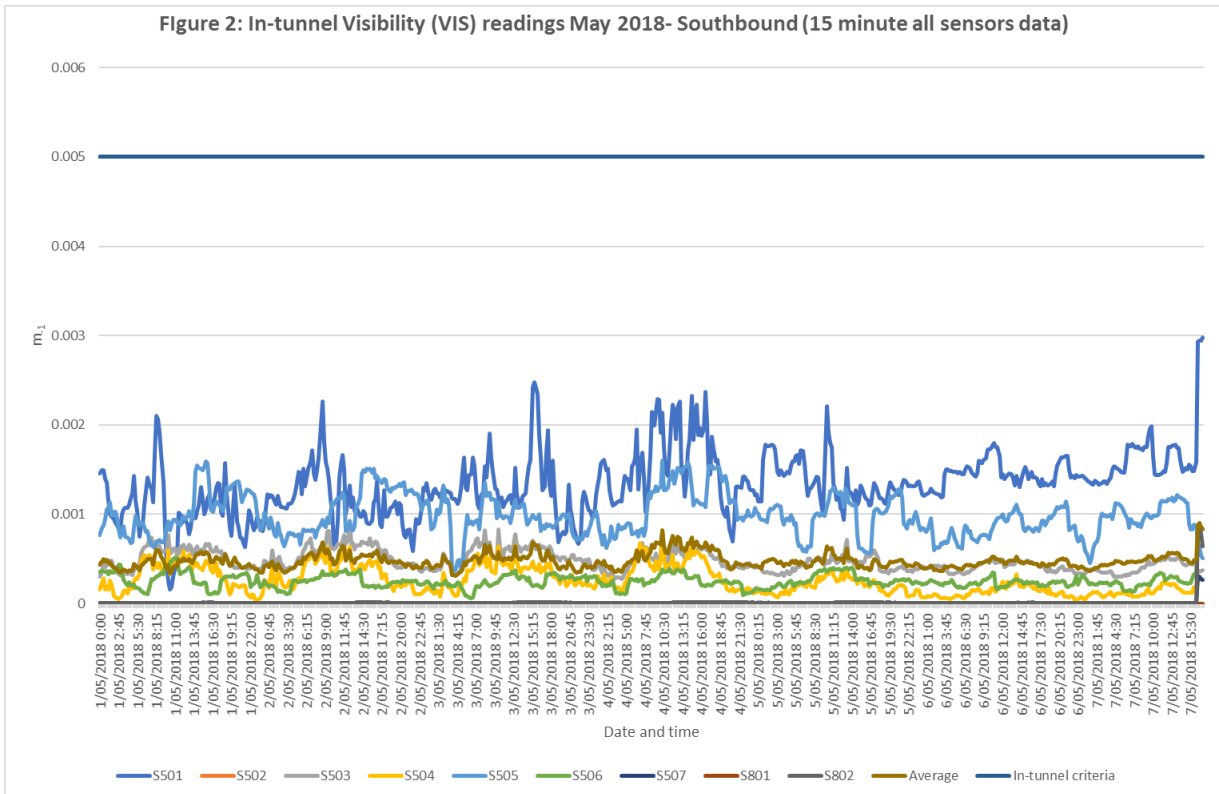
Visibility

- For the month of May 2018 no notable trends have emerged, with the exception of some erratic behaviour of visibility sensors S101, S102 and S401 in the northbound tunnel, which are under investigation for corrective maintenance.

Note: Sensors S101, S102 & S401 have been noted as behaving erratically and are under investigation for corrective maintenance.
